Technical Report

R-927

LATERALLY LOADED PARTIALLY PRESTRESSED CONCRETE PILES

NAVAL CIVIL ENGINEERING LABORATORY PORT HUENEME CALIFORNIA 93043-5003

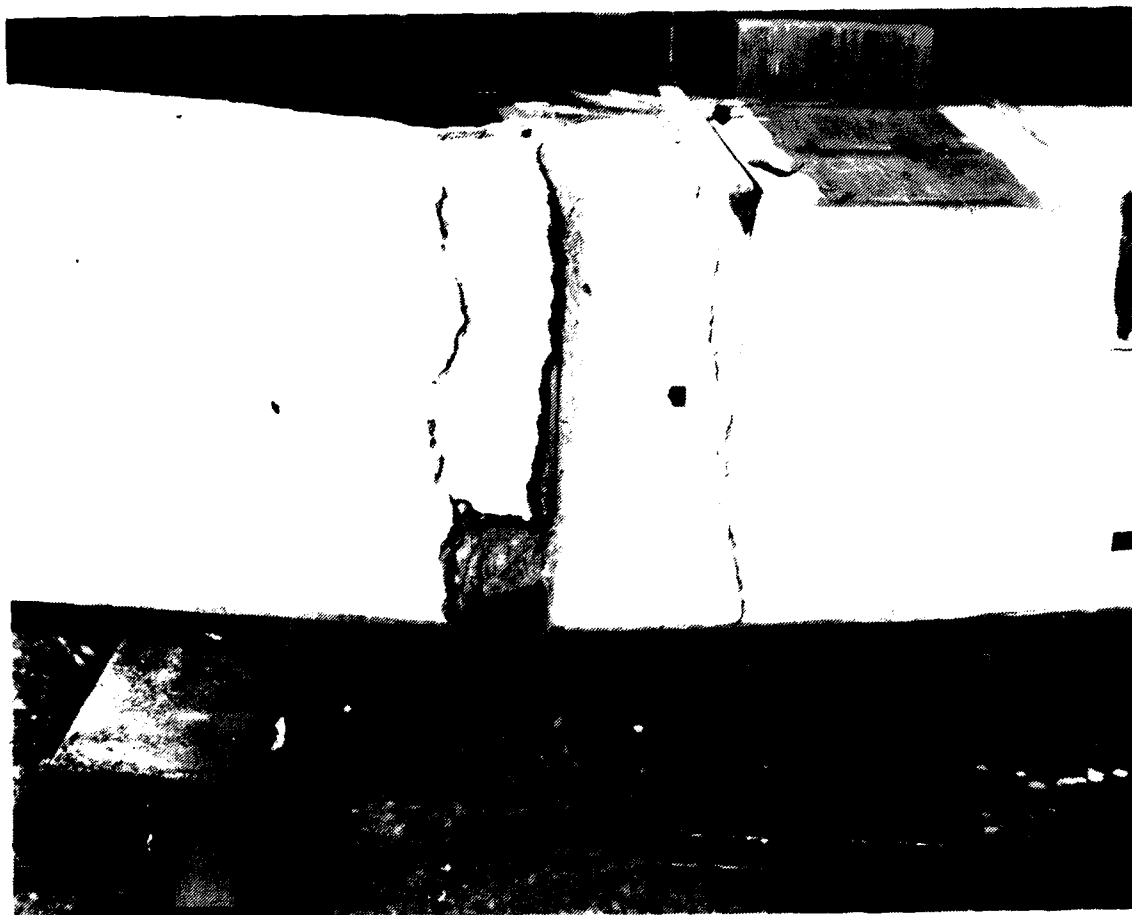
Figure B-4. MK1 post-failure tensile cracking at the load point.

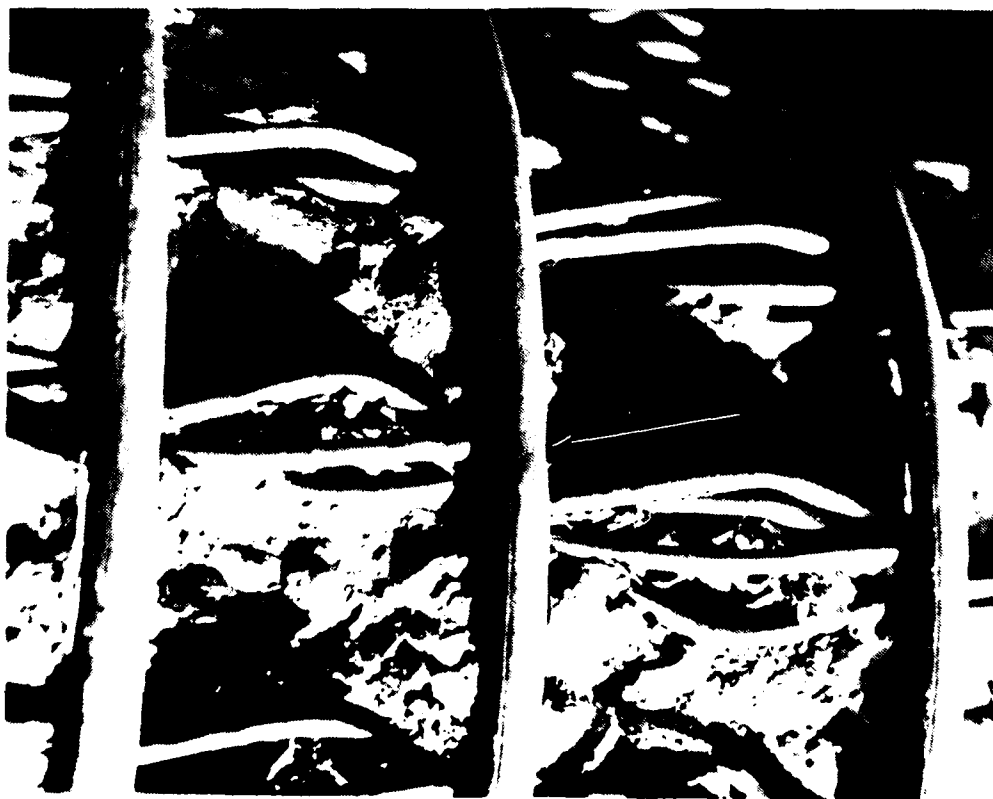
Figure B-81. MK7 spiral yield and necking in the spall zone.

Within Configuration A, the two specimens (MK7 and MK8) that were prestressed 2-1/2 times more than all other configurations sustained no ultimate loading enhancement. However, the stiffness of MK7 and MK8 was almost twice that of the others which resulted in half the energy absorption at ultimate loading (20 to 22 ft-kip). Energy absorption at failure was also substantially less for higher prestress force. Higher prestressing force may have caused greater distress to the confinement reinforcement. There was spiral yielding in MK7.

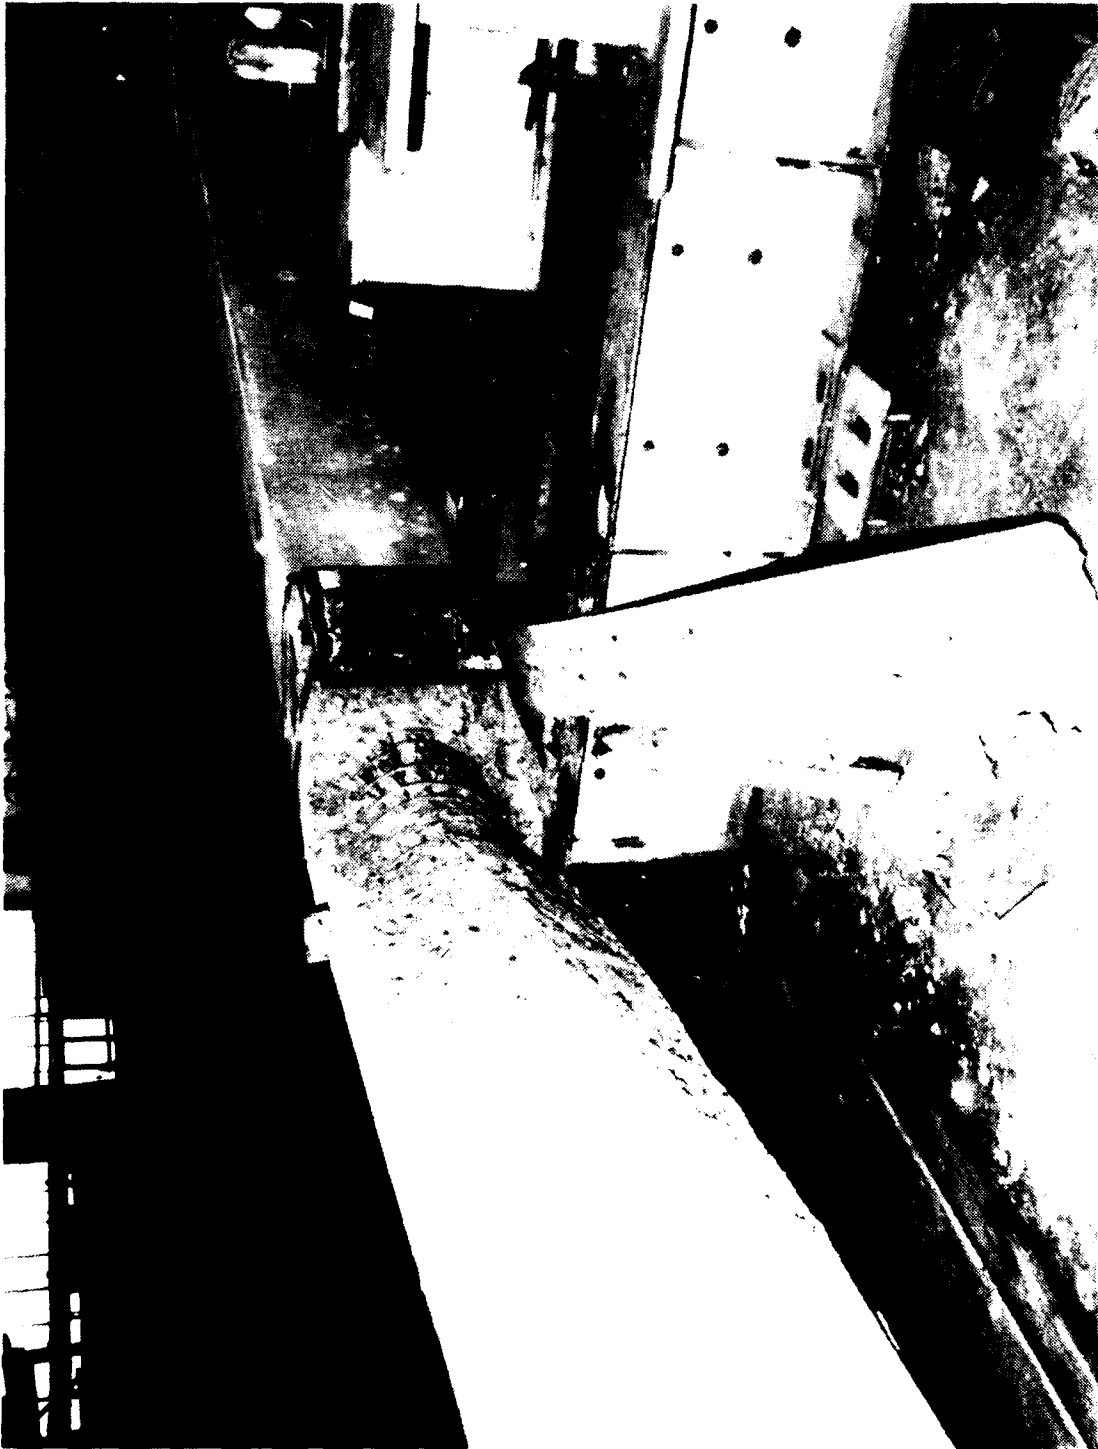
Figure B-98. Compression spall zone of MK3A.

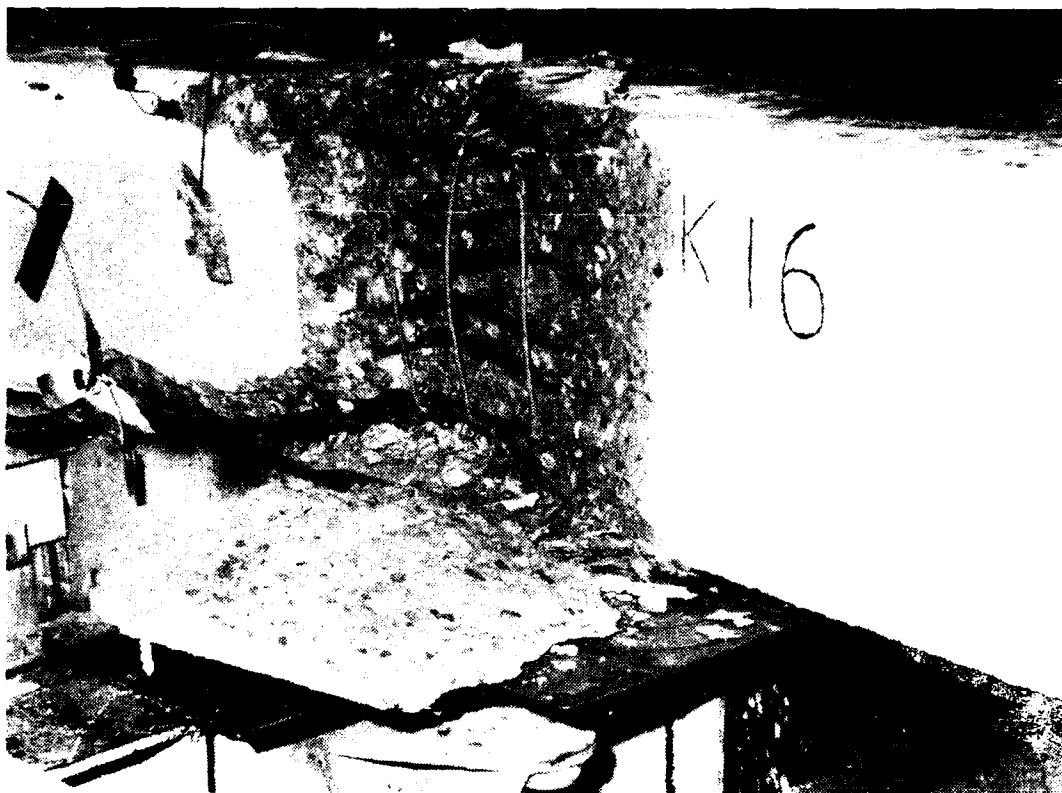
Figure B-167. MK16 compression spalling at failure.

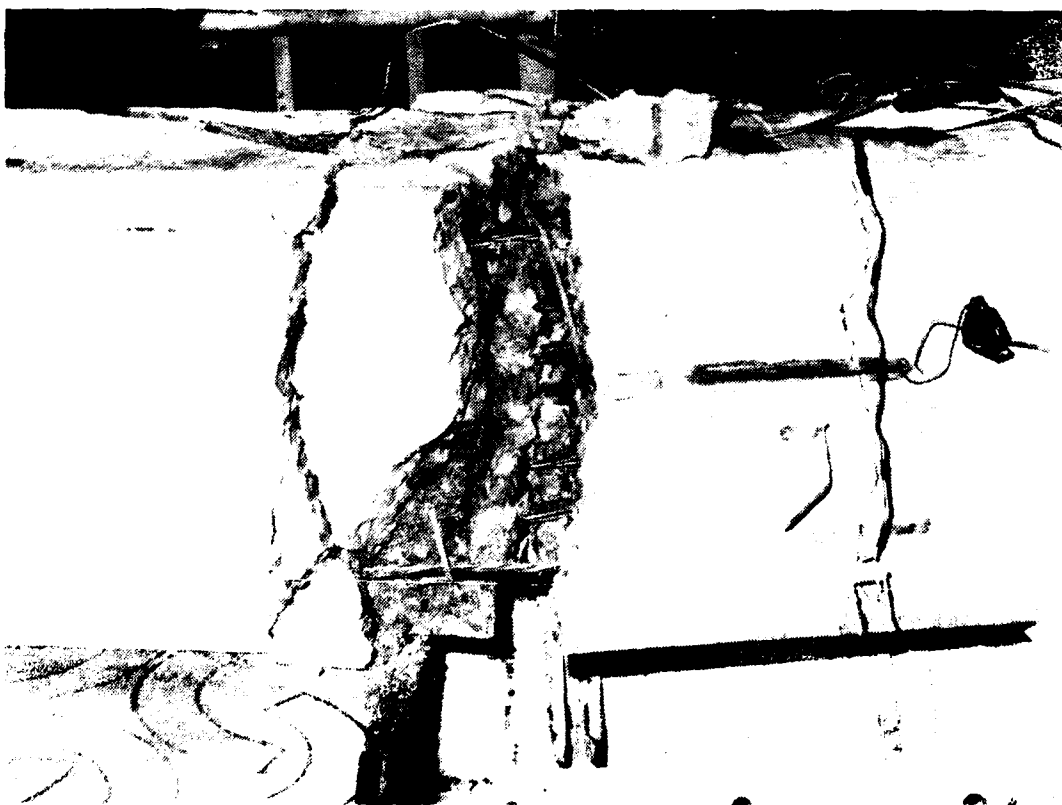
Figure B-168. MK16 tension cracking at failure.

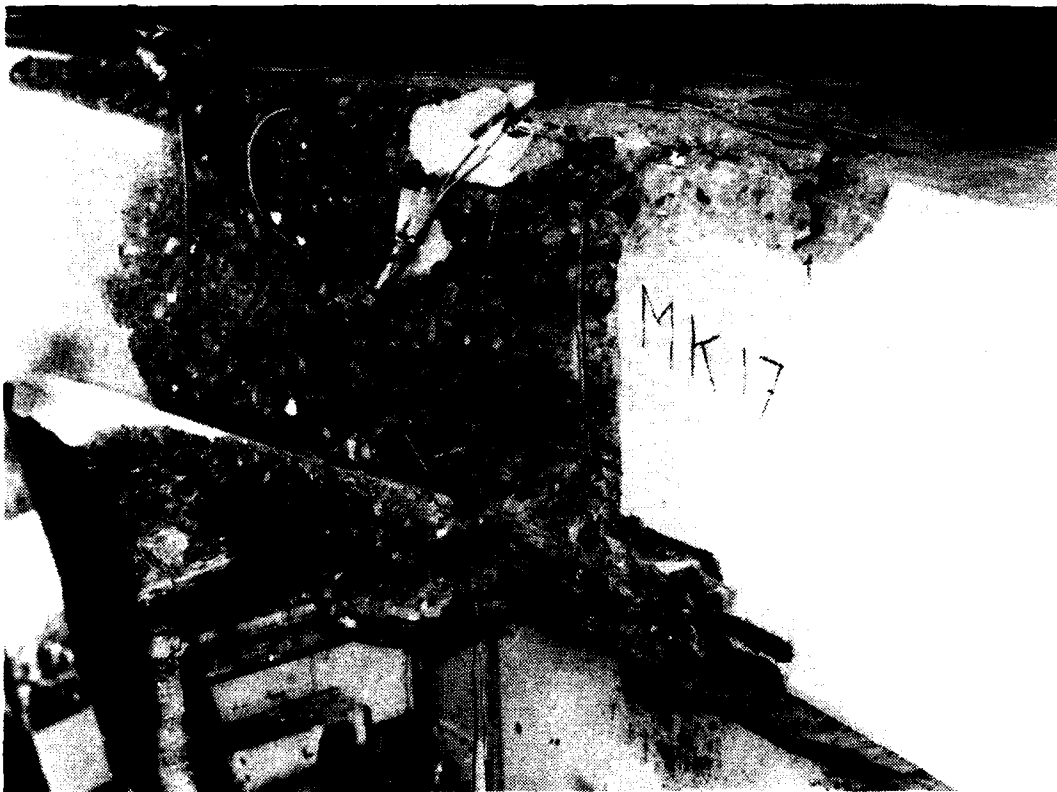
Figure B-172. MK17 compression spalling at failure.

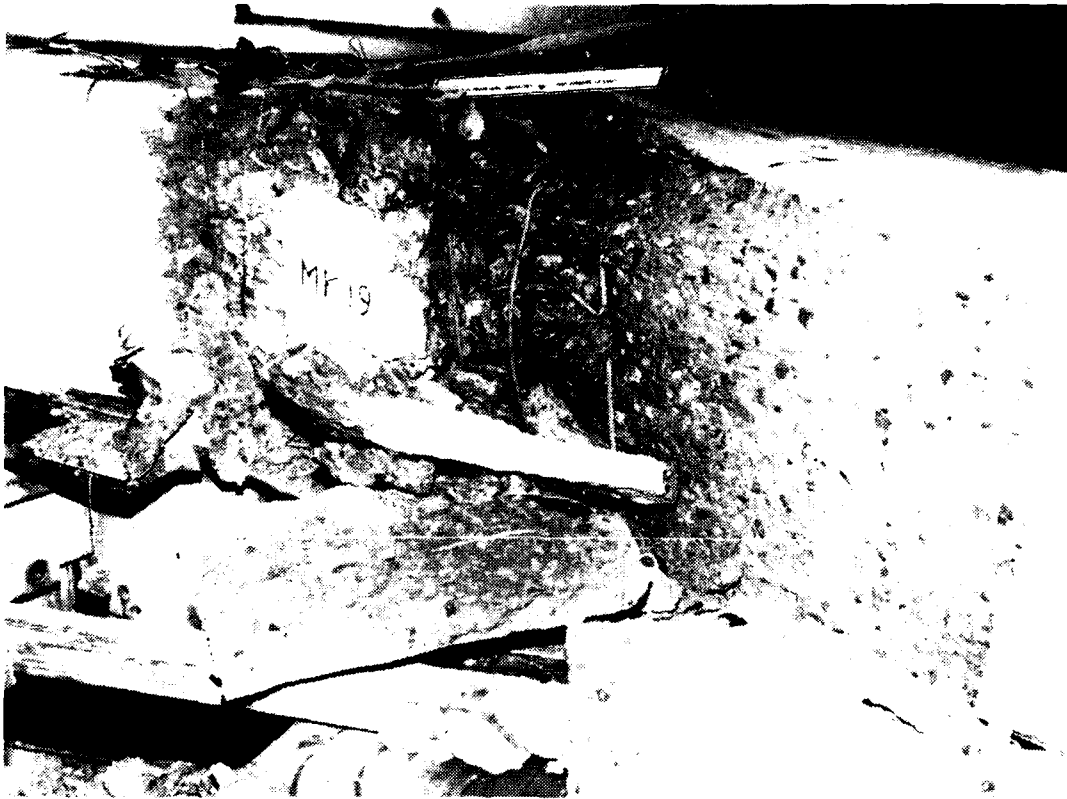
Figure B-187. MK19 compression spalling at failure.

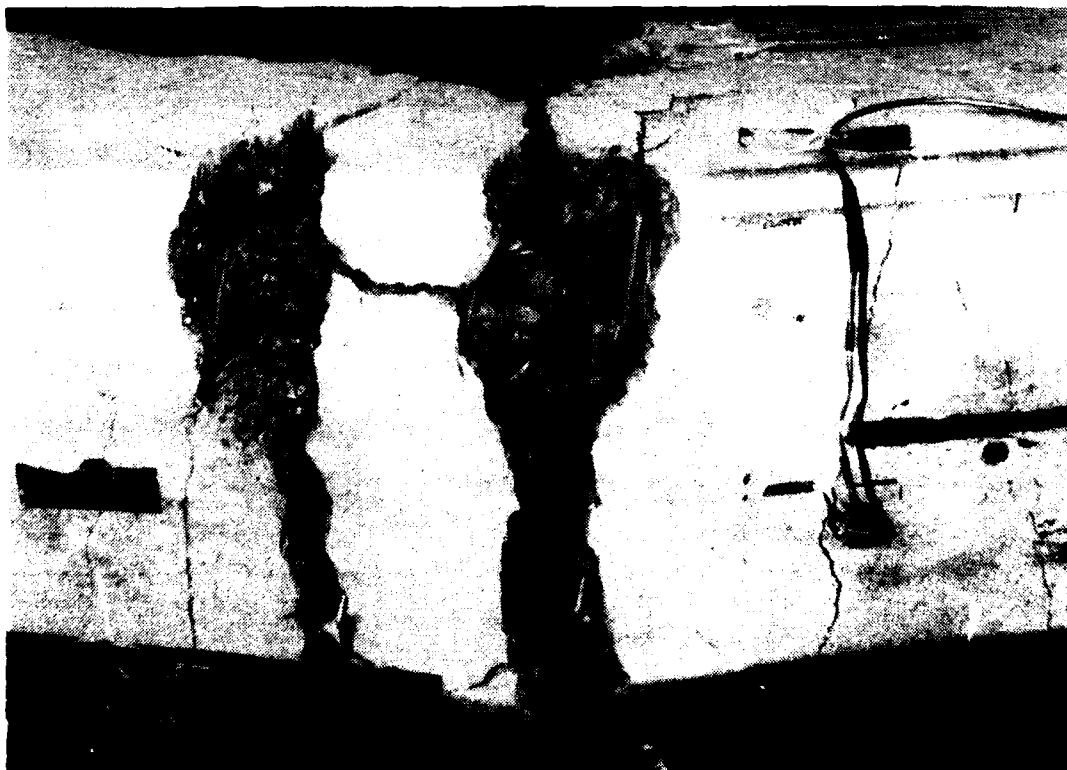
Figure B-207. MK22 tension cracking at failure.

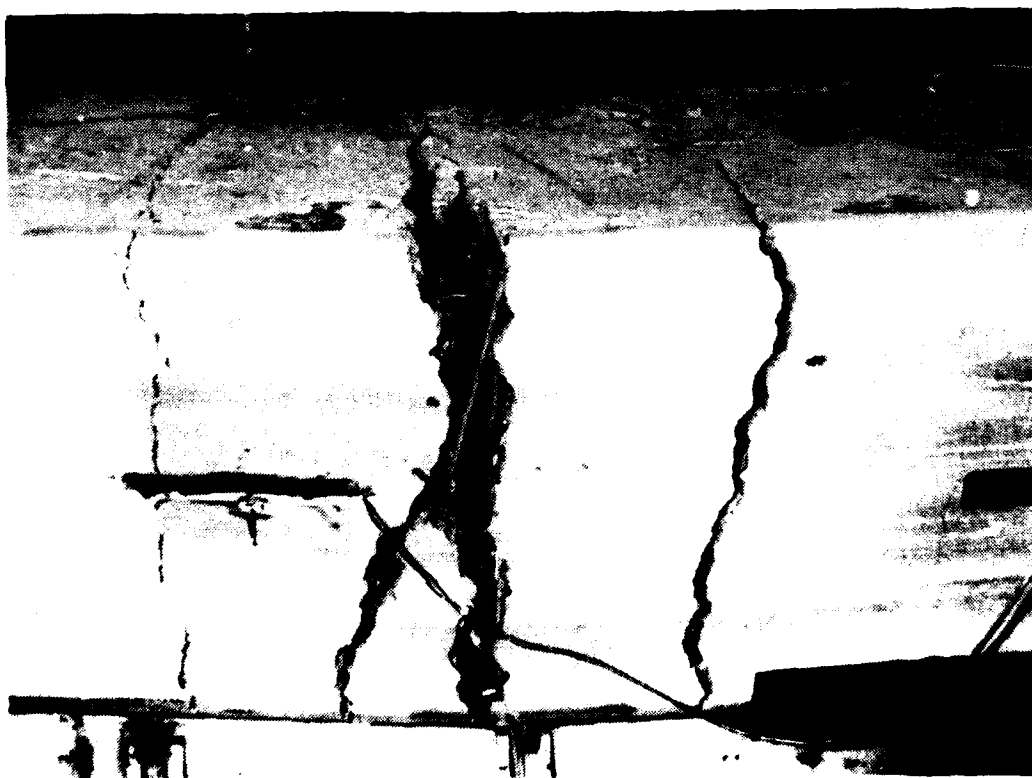
Figure B-216. MK23 tension cracking at failure.

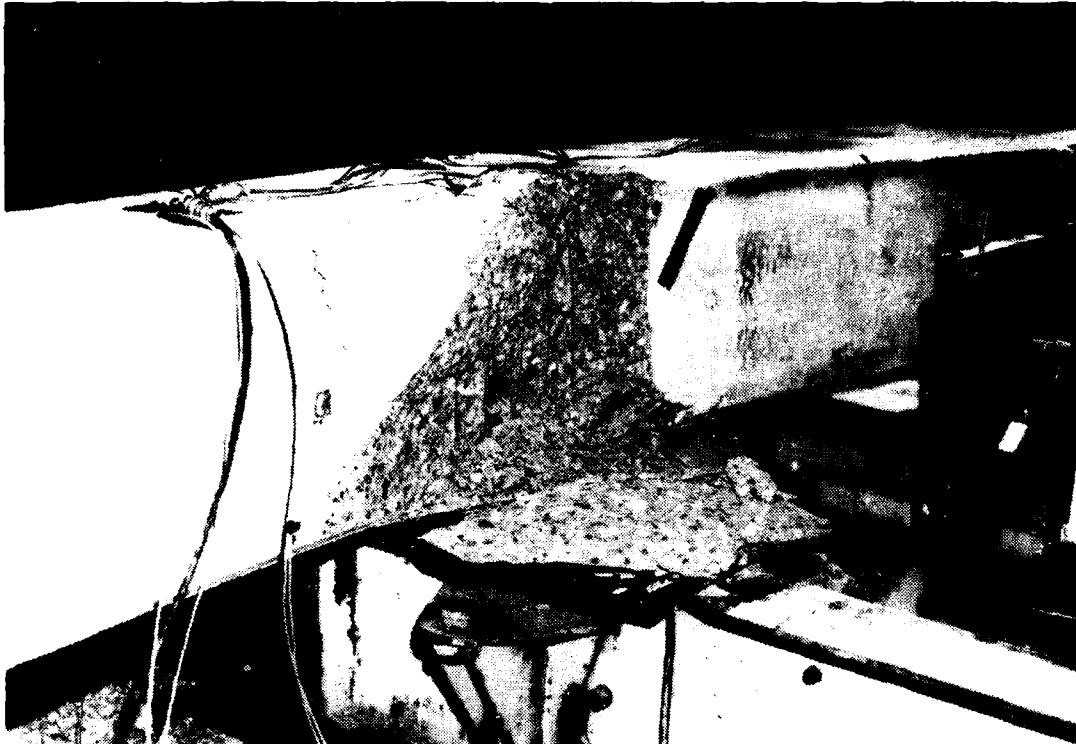
Figure B-231. MK5A compression spalling at failure.

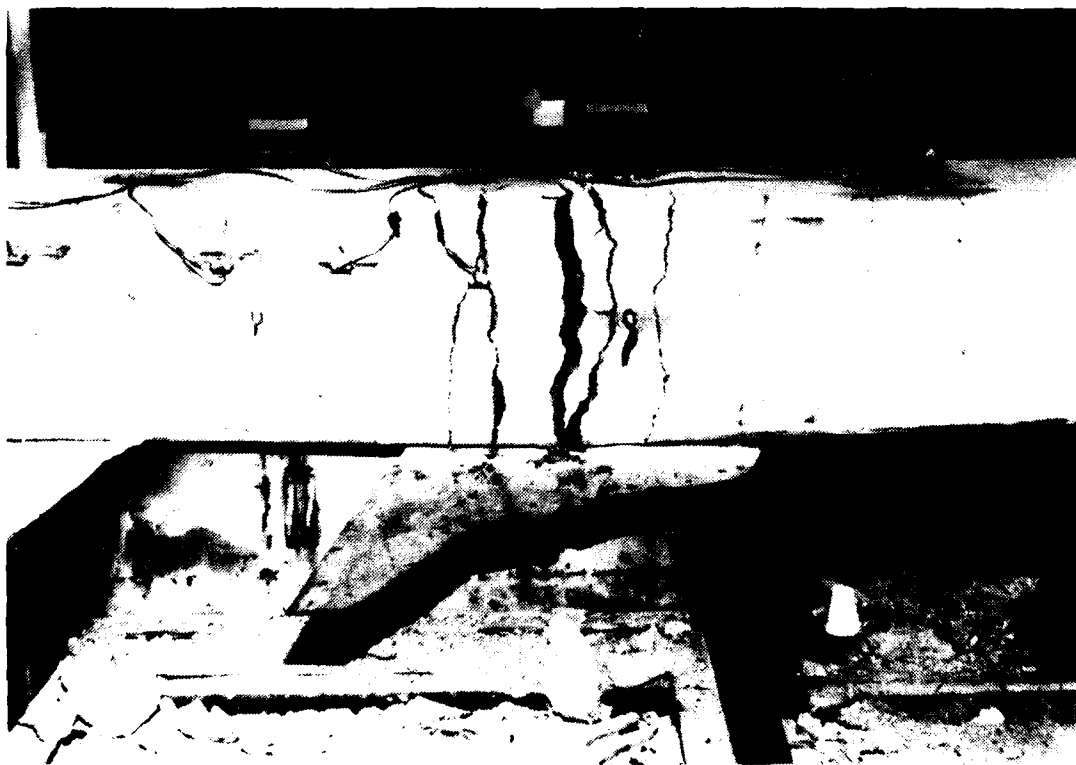
Figure B-232. MK5A tension cracks at failure.
